FACILITY CONDITION ASSESSMENT

Bay Bluffs Emmet County Medical Care Facility
750 East Main Street
Harbor Springs, Michigan 49740

May 12, 2021
Partner Project Number: 21-311094.1

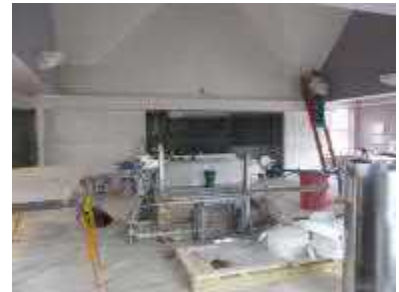
Of note, the Lilac Lane and Trillium Lane dining rooms are out of use and are in the process of being renovated. As part of the renovation, these dining rooms will each be fitted with commercial cooking equipment. It was reported that the dining room renovation and construction of kitchens within these dining rooms is being paid on bond and the costs for the purchase and installation of the commercial kitchen equipment along with the purchase of the new commercial cooking equipment in the main kitchen is on the order of \$140,000. During the survey the drywall was being finished, cooking hoods had been installed. It was not reported how much of this budget had been spent. Finish construction of new dining rooms/kitchens as per the scope. An opinion of cost for this work is included in Table 1.

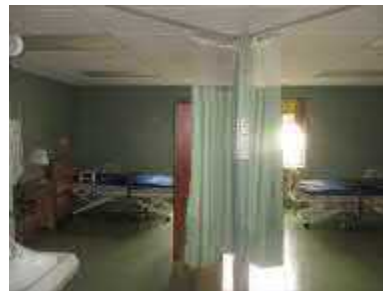
Resident room interior finishes range from good to fair condition. Interior finishes appear to be older and it was reported that most finishes date to the 2004 addition/renovation activities. As part of resident room upgrades it may be prudent to remove or replace the partial walls that are present in some rooms that provide a separation between the two sides of a double occupancy room. This is a management decision.
