FACILITY CONDITION ASSESSMENT

Bay Bluffs Emmet County Medical Care Facility
750 East Main Street
Harbor Springs, Michigan 49740

May 12, 2021
Partner Project Number: 21-311094.1

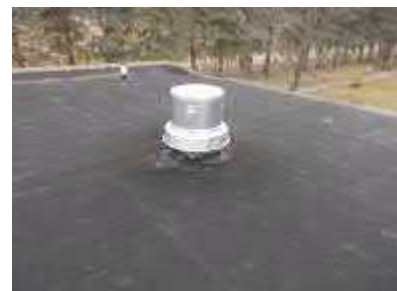
Ventilation is provided by a combination of RTACs, RTUs, and natural air infiltration via various doors and windows. There are a series of roof-mounted exhaust fans serving the various resident rooms, toilet rooms, common areas and the House Storage/Support wing spaces.

The RTACs and RTUs were observed to be in fair-to-poor condition overall and are nearing the end of their EUL. Management reported that several of the rooftop units were not functional including RTAC-17, RTU-21 and RTU-22. The non-functional units serve the House Storage/Support wing space, the Birch Blvd. resident rooms, and a portion of the central core area.

All rooftop equipment was noted with condensate discharging directly onto the roof membrane, which will eventually cause erosion and excessive wear of roof surface at point of discharge. Regardless whether

the rooftop equipment is new or existing, we recommend redirecting the condensate to the nearest roof drains by the installation of PVC piping. Costs are included in Table 1.

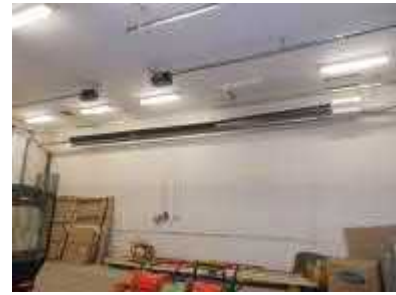
There is no HVAC equipment in the Storage Building, and the Maintenance Garage is heated by a pair of gas-fired unit heaters and a pair of gas-fired infrared tube heaters, all manufactured by Reznor. Ventilation for both of these support buildings is provided by natural air infiltration via man doors and overhead doors.

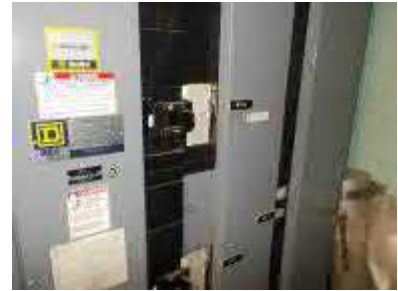
The primary electric service for the Subject extends below grade from the exterior concrete pad-mounted transformer, located adjacent to the north sidewall of the boiler room, to the electrical switchgear in the main electrical room of the House Storage/Support wing. A 1,600-amp, 480Y/277-volt, 3-phase, 4-wire, service is provided. The building meter is located on the electrical transformer.

Electrical gear and equipment all appeared to be in good-to-fair condition. No information was available as to when the last thermographic survey of the electrical switchgear was conducted. A thermographic survey should be performed at this time to identify areas of concern, including hot spots which need immediate repair. It is highly recommended that thermographic surveys be performed and continued on a semi-annual basis and that all electrical systems be shut down and inspected once every 5-years. Costs for the initial thermographic survey is included in Table 1. Ongoing inspections and allowances for anticipated repairs are included in Table 2.

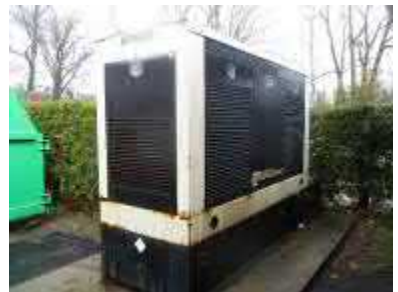
Emergency power is provided to the Subject building by an exterior concrete-pad mounted diesel-fired generator located adjacent to the electrical transformer on the north side of the boiler room and House Storage/Support wing. The generator rated at 160-kW, and is the standby system supplying emergency backup power to the entire facility, i.e. all power, lighting, computer systems, HVAC, life-support and life-safety equipment is fed from the generator at times of utility company power loss. The generator is manufactured by Kohler and was installed in 2004. The system operates on diesel fuel stored in a belly tank with a capacity of 200-gallons.

Property management reported that the emergency generator is run-tested weekly for 15 minutes, with full load-bank testing on a monthly basis. The monthly testing typically results in a dip in power to the building, dimmed lighting, and faulting of the facility telephone system. We recommend conducting a load study to determine peak electrical demand as well as to assess existing electrical usage and planning for future expansion of electrical need. An allowance for this study is included in Table 1. Additionally, to allow for the study to yield actionable information, the generator should be overhauled at this time to

extend the life of the unit. A cost for this work is also included in Table 1. Based on the age, current condition and the inability of the unit to provide the proper electrical loads during shutdown, we recommend a full replacement during the capital term. All works should be completed in accordance with the electrical load study. The replacement capacity of the unit is estimated for budgeting purposes.

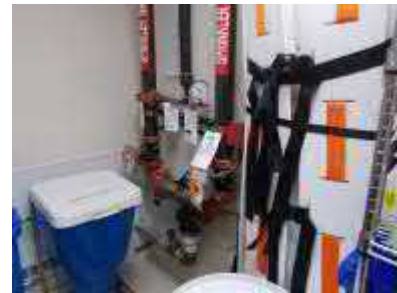
The building is fully protected with a wet-pipe sprinkler system utilizing steel piping. As noted above, the 4" diameter building water main enters the boiler room and splits into the domestic and fire protection service lines. The system is complete with fire department connections and outside stems and yokes (OS&Y) which are located on the exterior sidewalls immediately outside of the main risers. Fire sprinkler piping appeared to be steel. The municipal water pressure is boosted by an inline 1/2-HP pump, manufactured by Dayton. Additionally, sprinkler risers are located in the Birch Blvd. wing living room/sunroom, and the Lilac Lane wing mechanical room.

The fire suppression system appeared to be in good-to-fair condition overall. The system is tested on an annual basis, and current inspection tags were observed on the main risers in the boiler room, with the inspections conducted by John E. Green Company, and dated 14 September 2020.

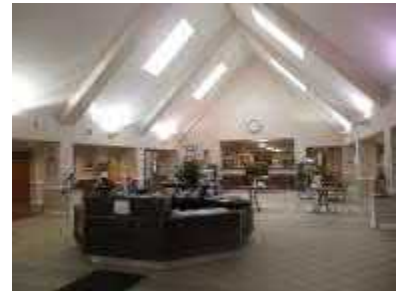
The main lobby is accessed via the main entrance vestibule at the covered passenger drop off area at the south end of the building and encompasses a large open space or main central corridor that also includes the café, living room and activity alley. The lobby and café portion have a sloped ceiling that is more than 20 feet at its peak and features four skylights. This portion of the building is finished with ceramic tile and vinyl tile flooring, painted drywall or vinyl-covered walls and painted drywall ceilings and ACT ceiling systems with drywall bulkheads creating a coffered appearance. FF&E in these areas consist of the reception desk, numerous tables and chairs (many of which have been placed aside due to COVID social distancing requirements), couches, desks, etc.

Common area interior finishes range from good to fair condition. It was reported that flooring in the common corridors (except Birch Boulevard) was replaced in 2018. Remaining flooring appears to be older and it was reported that most finishes date to the 2004 addition/renovation. The following deficiencies were noted that warrant attention.

Interior corridor/common area FF&E including the reception desk, nurses' stations, couches, tables and chairs, etc., typically dates back to the 2004 addition/renovation activities. Replacing the aged/worn common area FF&E is recommended at this time. An opinion of cost for this work is included in Table 1.

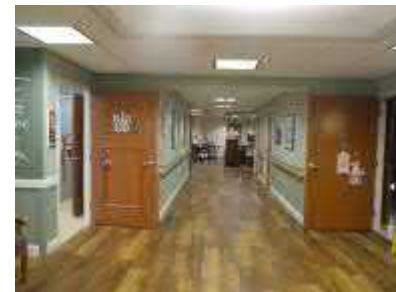
Common corridors that provide access from the main central corridor through the Lilac Lane, Trillium Lane, Wildflower Lane, Apple Blossom Lane and Birch Boulevard resident wings and the supply/support wing within the building. Nurses stations are located within the Lilac Lane, Trillium Lane corridors, and at the intersection of the Apple Blossom, Wildflower and Birch Boulevard corridors. Finishes in these areas consist of vinyl plank flooring, painted drywall or vinyl-covered drywall walls with chair rails and suspended ACT ceiling systems. FF&E include the nurses station desks.

Several ceiling tiles particularly in the corridors exhibited staining from current and former roof leaks and/or HVAC piping leaks. Repair current leaks (if any) at these locations and remove and replace the stained ceiling tiles with similar to match existing. An opinion of cost for this work is included in Table 1.
